**SOLID, SAFE  
AND LASTING**

# Windsor Bridge, NSW.

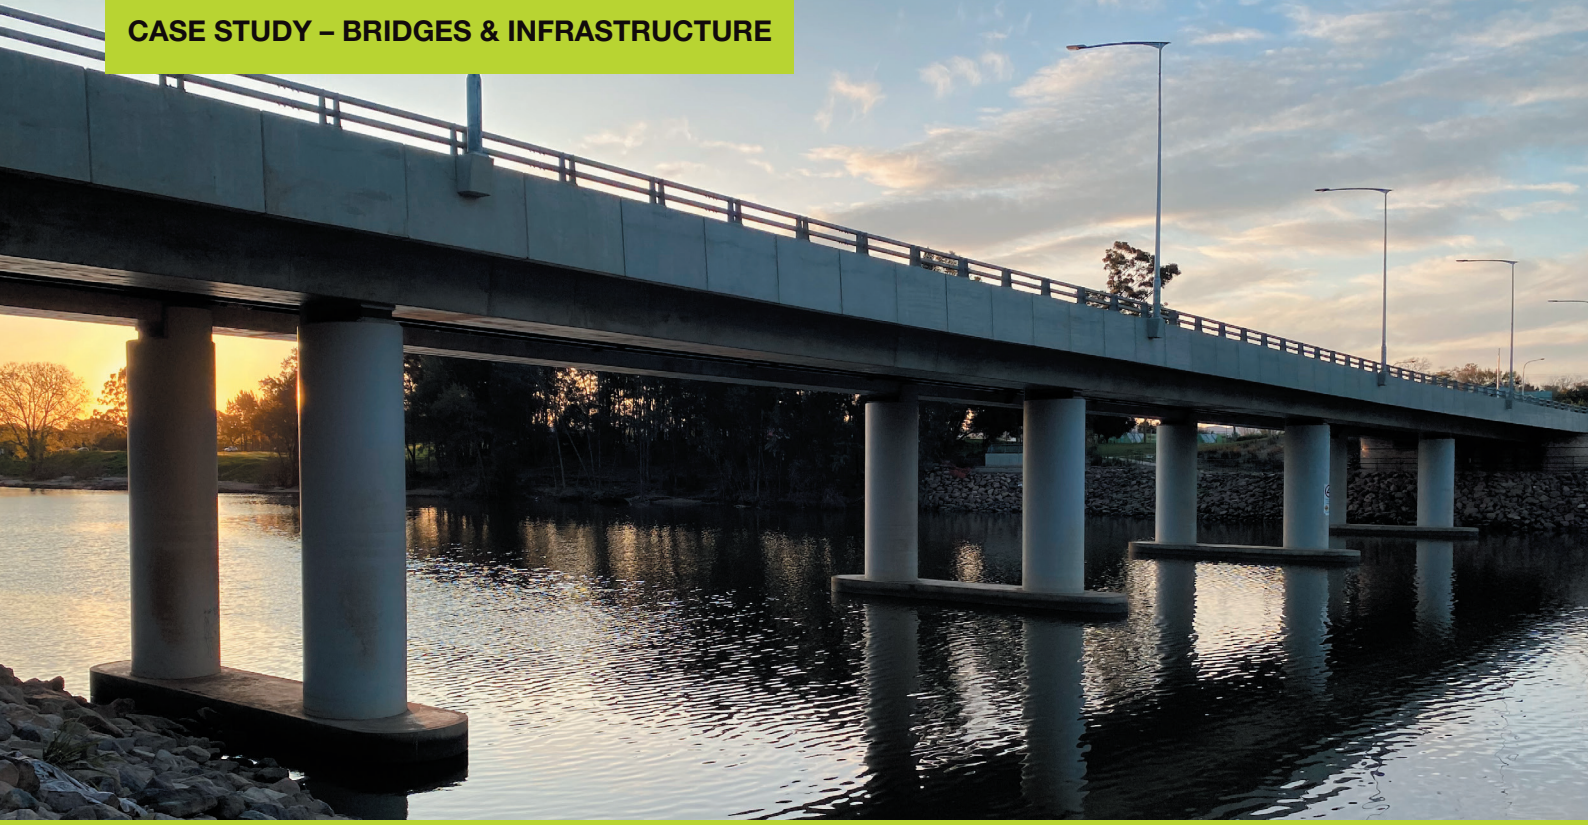
Delivered by contractor Georgiou, the new bridge was constructed as an incrementally launched bridge, with 10 concrete segments cast in a bed on the northern bank before being launched across the river.

The bridge superstructure is supported by four piers in the river. The piles for these piers were constructed from steel tubes filled with reinforced concrete, then topped with precast concrete pile cap 'shells' filled with concrete to support the bridge columns.

The bridge faced its first major flood test in March 2021 - less than 12 months after completion - when it was submerged during the disastrous Eastern Australia floods. In March 2022 it was again flooded during another significant East Coast weather event, major flood event in July 2022.

Although the bridge went under water on each occasion, it re-emerged structurally sound - meaning this essential piece of infrastructure could be reopened to the community much more quickly than would have been the case with the old bridge.
