Use of the 5th (non-standard) chute

Be aware. Be alert.

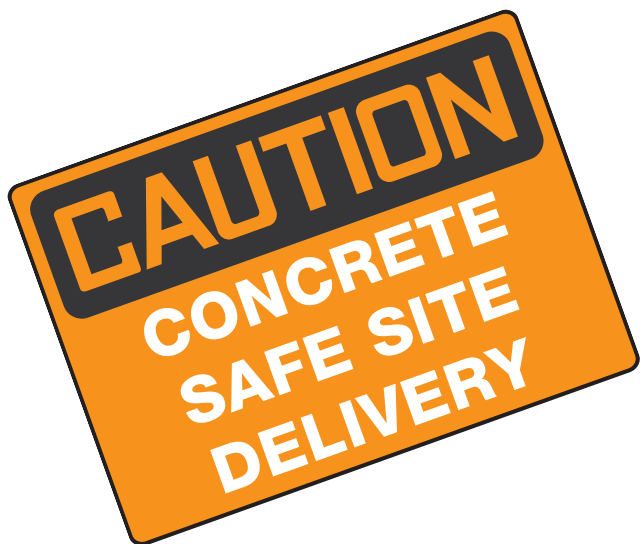
Industry experience is that the use of additional chutes can contribute to the failure of the chute jack arrangement.

1. No additional chutes are to be added to trucks (only use those supplied on a truck by the manufacturer) ie **NO** 5th chute
2. Customers and contractors should not be permitted to access or operate any part of the truck or mixer.
3. When moving a truck with extended chutes a spotter must be used - and the chutes must be locked
